# Pre-Purchase Inspection

14 Brumby Lane, Yarra Valley VIC 3130

| REFERENCE | SS-AAAC4A |

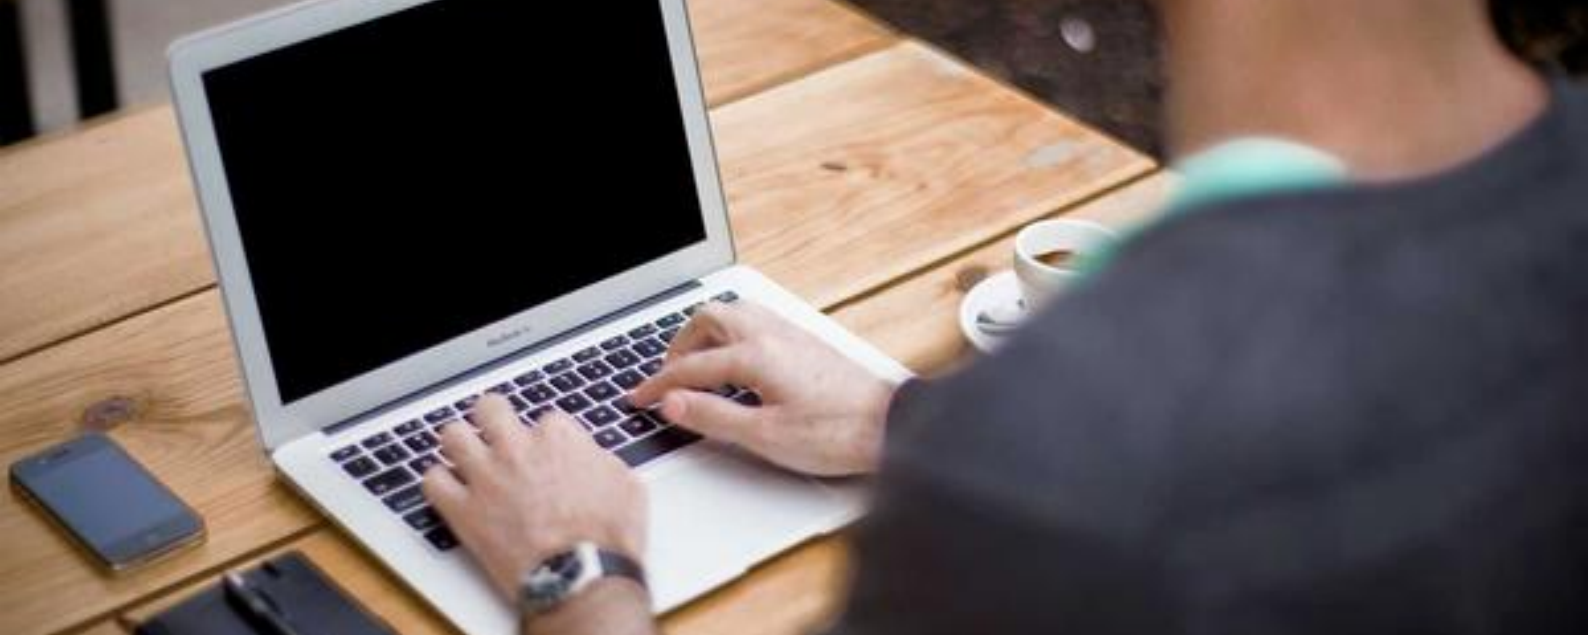
Fig 1.1 — Overview — front elevation

Recommend roof cleaning and valley treatment. Gutter reattachment and clean. Repaint south fascia after moisture investigation. Replace two double-glazed units on first floor — failed seals.

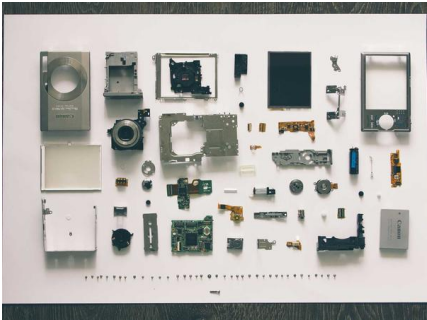
Fig 1.2 — Roof and gutter condition

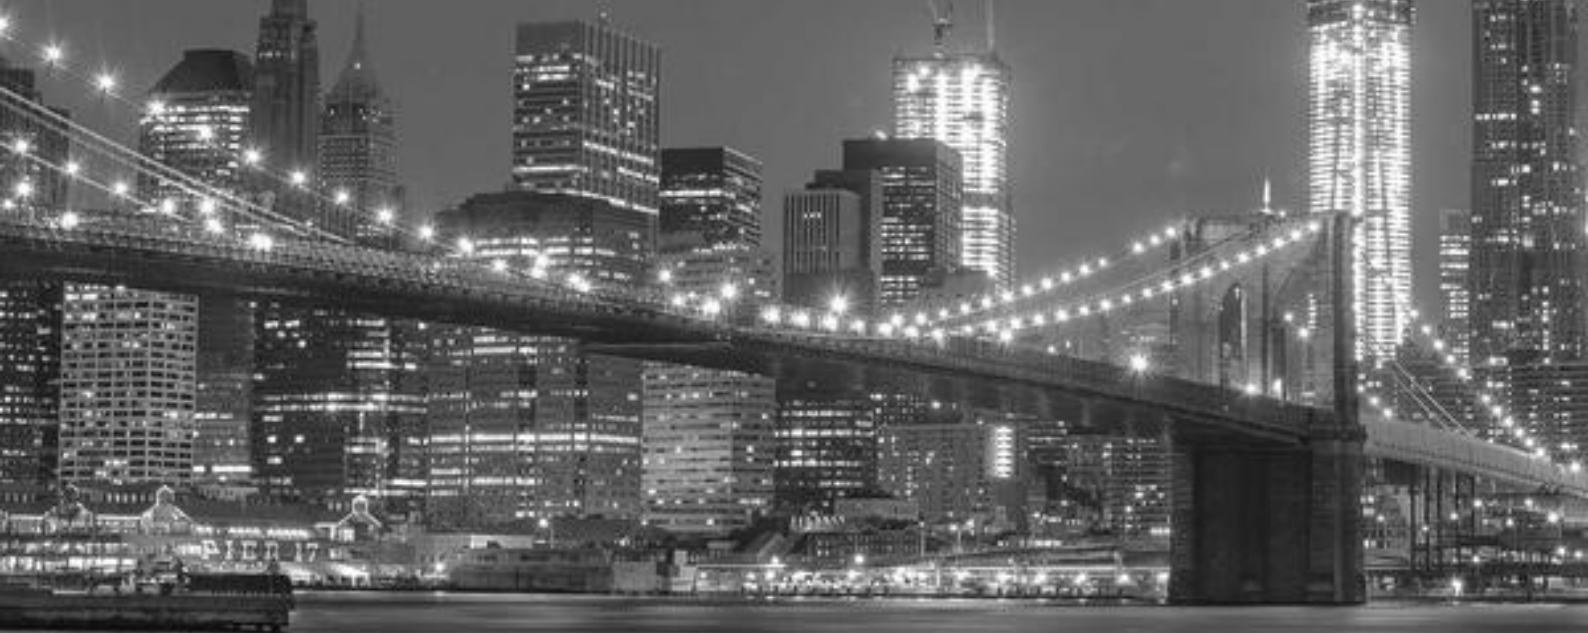
Fig 2.1 — Overview — shower and vanity wall

Bathroom: Fair condition. Shower base — grout cracking and evidence of movement. Recommend full regrouting minimum. Vanity — cabinet doors delaminating at base. Toilet operational.

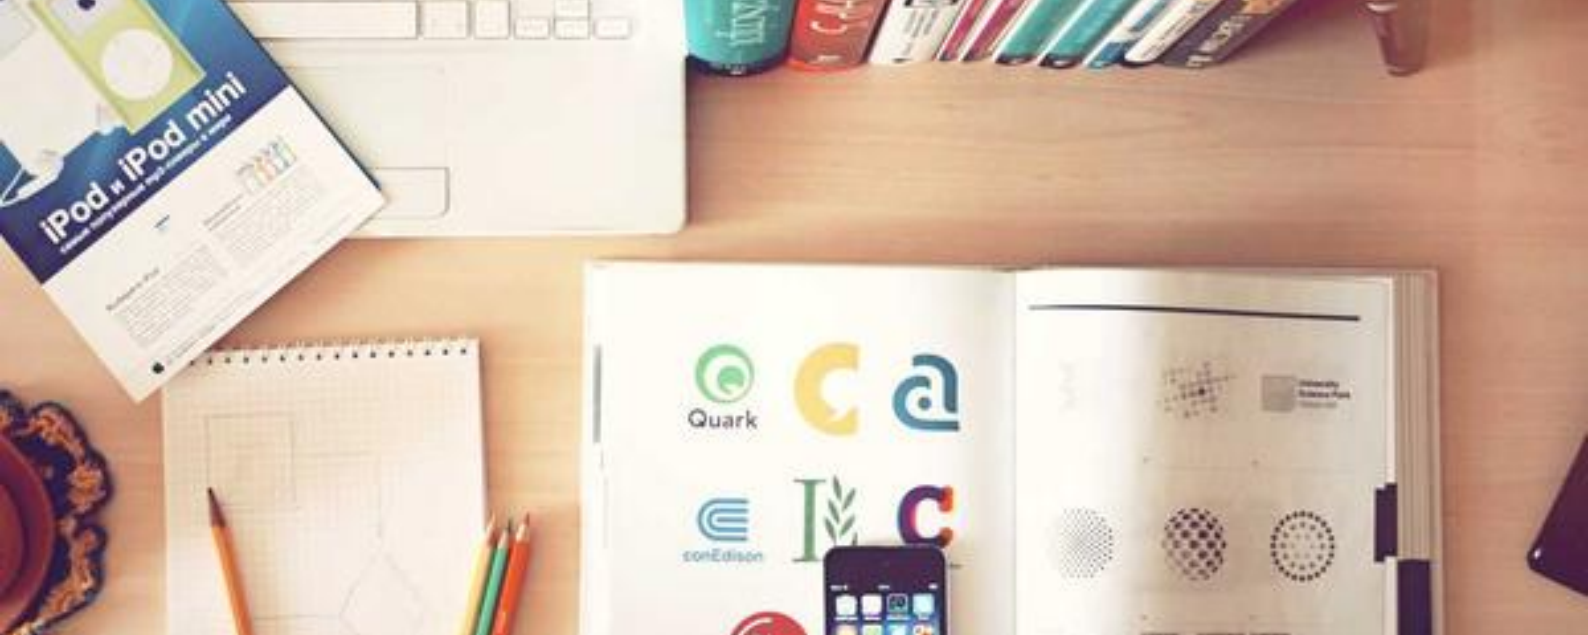
Fig 3.1 — Overview — north wall, existing cabinets

Kitchen: Fair condition. Lower cabinet panels swollen — water history under sink. Rangehood functional. Flooring — chipped tile near dishwasher, not structural.

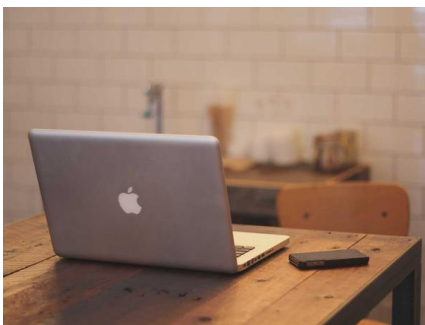
Fig 3.2 — Benchtop condition at sink corner
